Lightning Protection of Golf Courses and outdoor activities

Alain Rousseau, Fernanda Cruz
SEFTIM

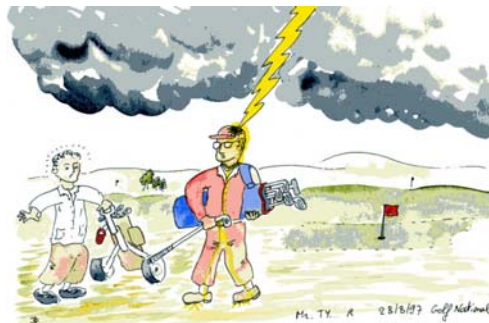
Fig. 1. Real example of a strike on a gof player near Paris

The most common case is the direct lightning strike on the golfer himself. It is facilitated by the fact that he often stands on an open area, higher than the surrounding space. Moreover, he can hold up towards the storm cloud objects like a golf club or an umbrella. The lightning current then passes through the body of the unfortunate golfer, being able to follow two paths:

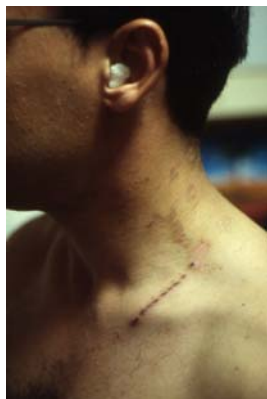
Fig. 2. Injury to a golfer, same case than Figure 1

- Either external at the surface of the body, burning the skin especially near the metal parts of clothing (necklace, belt buckle, jewels, etc.). Those electrical burns may be severe and deep, but not always. They tend to focus on the points of entry and exit of the current. A benign typical consequence of the external flash is the Lichtenberg figure yielding ramified red drawings on the skin along the current ways, which faint and disappear in a few days.
- Either internal flash that can cause internal injuries, the most serious being cardiac arrest by fibrillation if it crosses the heart during a vulnerable period. The nervous system, the muscles, the blood vessels may be injured too. Every body structure involved may be electrically stimulated or burned according to the amount of current delivered.

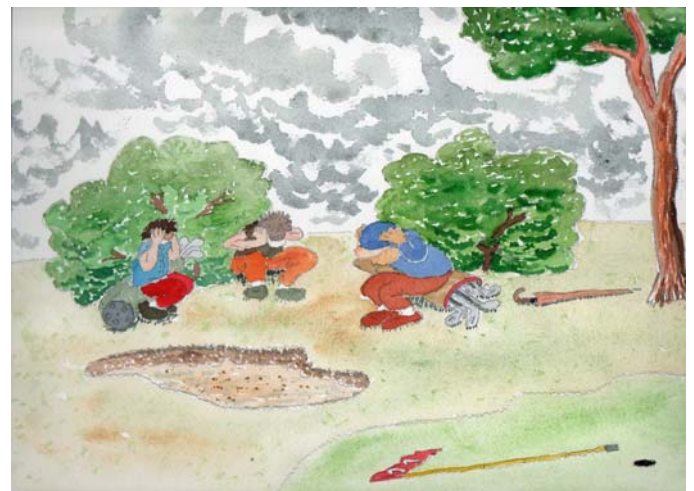
Fig. 3. How to be protected outside of a safe shelter ?

As people may be too far from a safe shelter the usual rules to follow to minimize the danger are to squat on the ground, to protect ears and to wait until the storm passes by.

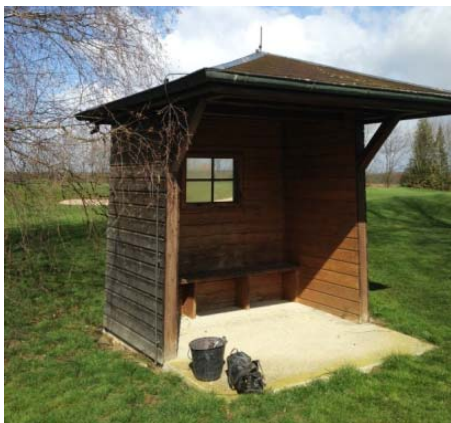
Fig. 4. Example of a shelter protected against direct strike

A suitable and standardized protection scheme [2] should be implemented not only on the club house but also on local shelters following a preliminary lightning risk assessment. As a matter of fact, distance may be quite large between the isolated golfer and the club house. Protection of the club house will include lightning rod(s), downconductors and a suitable lightning earthing system. Surge protective device should also be implemented due to the presence of the lightning rod but also to take care of safety devices (fire detectors, emergency telecom line, warning siren and so on). For the shelters that are supposed to protect the far away golfers, a lightning rod and down-conductor system should be implemented. Step and touch voltages should be taken into account by using specific rules (specific isolated downconductor, gravel, isolating material ...).

These safety rules are valid inside and outside the shelter in an area of 3 m around the downconductors. It should be a pity

that the lightning rod is catching the lightning strike but people are injured by a side flash or a step voltage. The lightning protection scheme should be defined by a professional having a justified qualification (such as Qualifoudre in France), installed by a professional with the same qualifications and finally inspected by a professional (different from the installer but could be the same than the designer) also duly qualified. A badly designed and installed LPS could be as dangerous as no LPS at all.
